Water and moisture damage to elevated floor structures across the United States results in costly insurance premiums due to claims, flood insurance, and individual out of pocket repair costs.

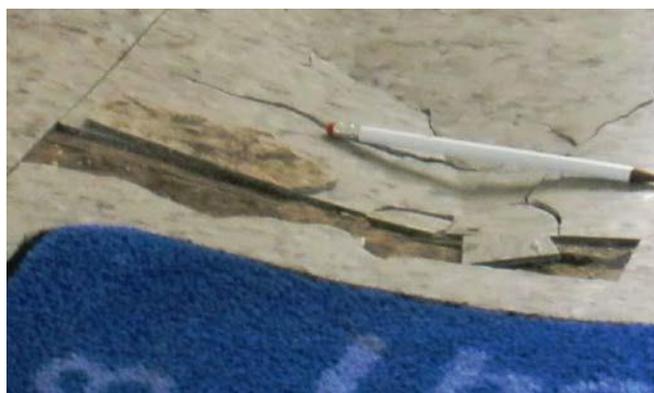
This photo shows an elevated floor that has decayed from inadequate ventilation below the floor surface. Note the collapsing of the floor.

- Structures should have open crawl spaces to reduce surge water resistance and allow for venting of moisture.
- Buildings with an enclosed crawl space (skirting) should have flood vents to allow flood water or surge water to flow freely under the structure and proper venting.
- The ground under the structure can be treated for insects.
- Protective moisture barriers can be installed, and the wood floor joists can be protected, with a variety of wood barrier products.
- The elevated area should be inspected periodically for signs of wood moisture content, wood fungi, wood decay, insects and pier conditions.
