The Hidden Danger Lurking in Your Electrical Box

A Quick Check of Your Circuit Breaker Panel Can Shed New Light on Your Electrical Hazard Exposure

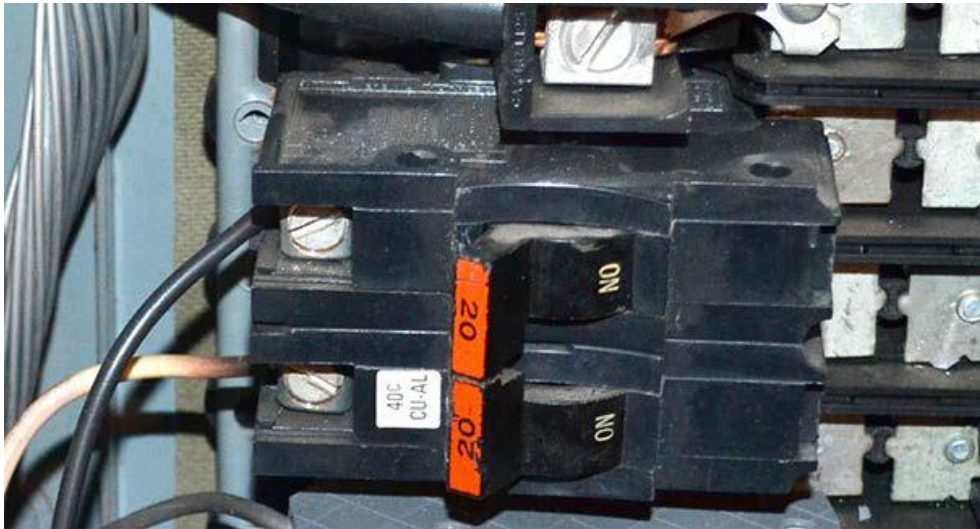
This is a close up view of a 20 ampere double-pole Stab-Lok breaker showing the handle shape and color.

Tests performed by the Consumer Product Safety Commission, and independent consulting engineers, concluded that certain *Stab-Lok* breakers do not trip according to requirements and in some cases can jam in the “on” position. This condition was most pronounced in the *Stab-Lok* two-pole version of the breakers.

Based on these issues, when a Federal Pacific Electric *Stab-Lok* installation is discovered, the safest course of action is to replace it with a completely new panelboard and breaker installation.

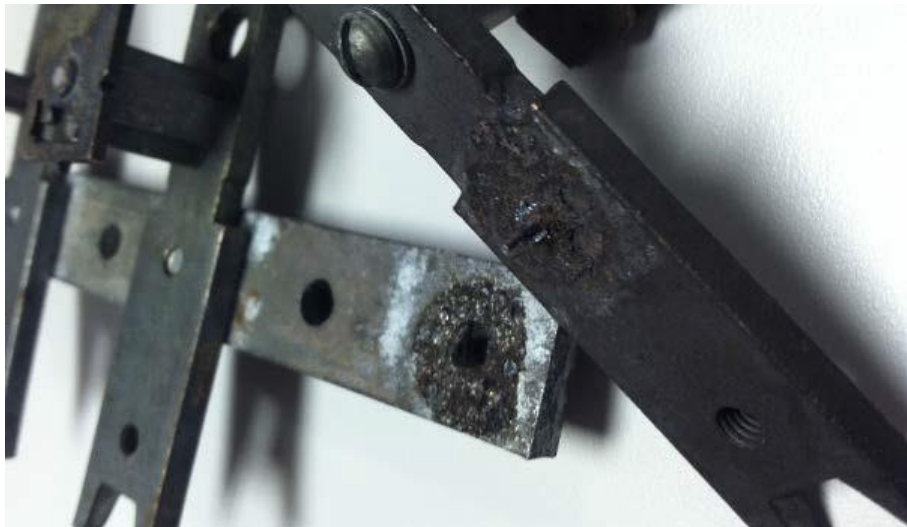
The *Stab-Lok* panels are associated with several problems related to the breakers not tripping and issues with internal connections on the busbars.

This is a failed, high-resistance, busbar connection inside a 200 ampere Stab-Lok panel. The arced-away steel screw holds the copper bar in the forefront to the aluminum bar in the background.
