SafeChurch® Deck Collapse Prevention

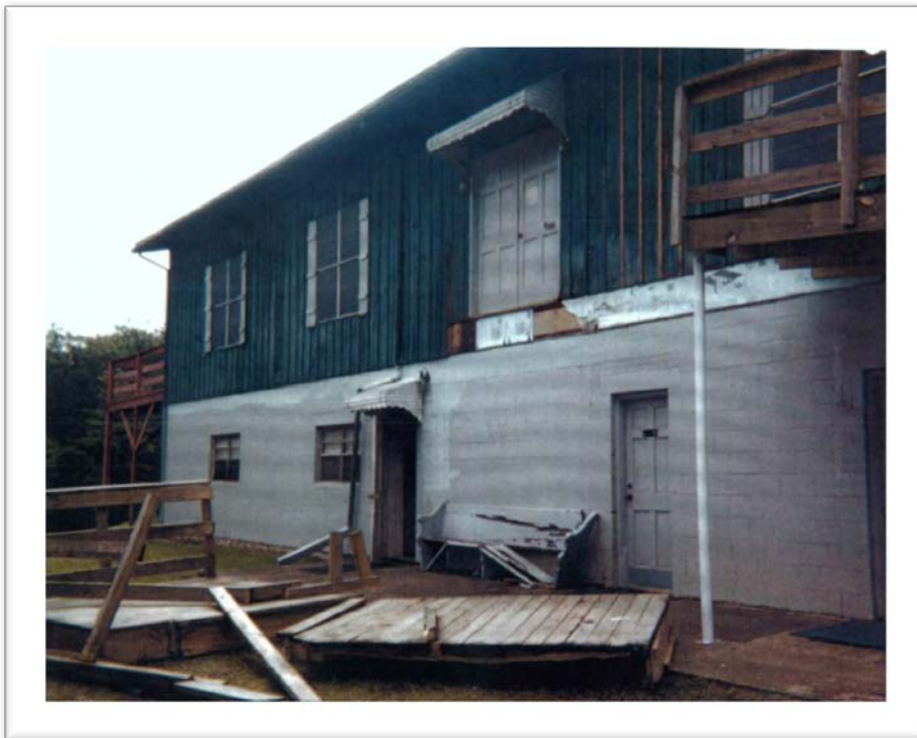
GuideOne also has experienced these types of claim. A church camp's wooden deck suddenly collapse where it had pulled away from the building as campers were standing in line waiting to enter the dining hall. Five people were seriously injured requiring surgeries and medical stays.

The photo shown here was taken after the accident. Note the complete collapse of the wood deck to the ground and the distance of the fall.

The main sources of deck collapse are failures of the connection between the deck ledger board (where the deck attaches to the building) and the building. The U.S. Forest Products Laboratory says that “nearly every collapsed deck has been attached with nails, rather than bolts, and investigators have pinpointed nails as the cause of the collapse.”
