Electrical: Air Conditioning Safety Disconnect

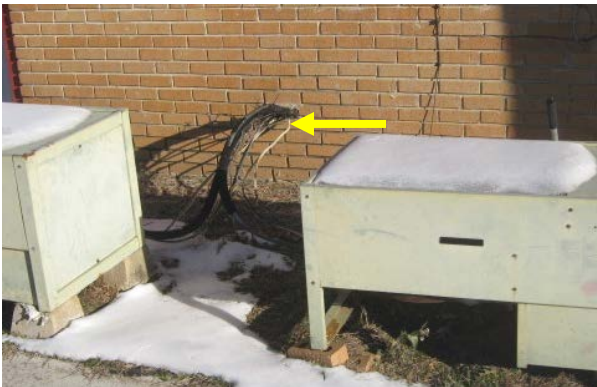
Image above shows an inadequate wiring set up for the central air conditioning units. Electrical is wired directly to the A/C condensing units, without a safety disconnect.

If your church does not have a safety disconnect installed for each air conditioning unit, a qualified electrician or licensed electrical contractor should be hired to complete this. This will ensure that the electrical work completed will meet current national and local electrical codes.

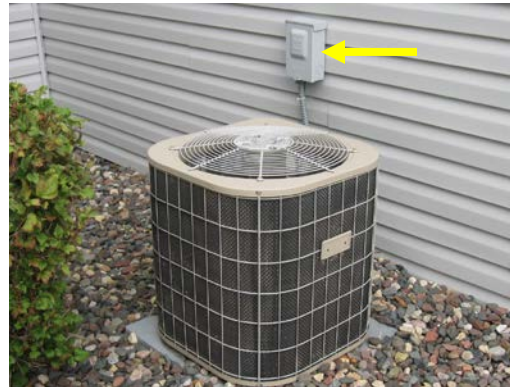
Image above shows the correct installation of an electrical safety disconnect switch.

This safety disconnect will have over current protection in the form of a circuit breaker or fuse. In the loss described above, the installation of an electrical safety disconnect would not have prevented the arc fault within the A/C unit, but the over current device would have prevented the down line damage to the main electrical distribution panel and subsequent fire and smoke damage.

Over current protection—circuit breaker or fuse.
