SafeChurch®

The Hidden Danger Lurking in Your Electrical Box

A Quick Check of Your Circuit Breaker Panel Can Shed New Light on Your Electrical Hazard Exposure

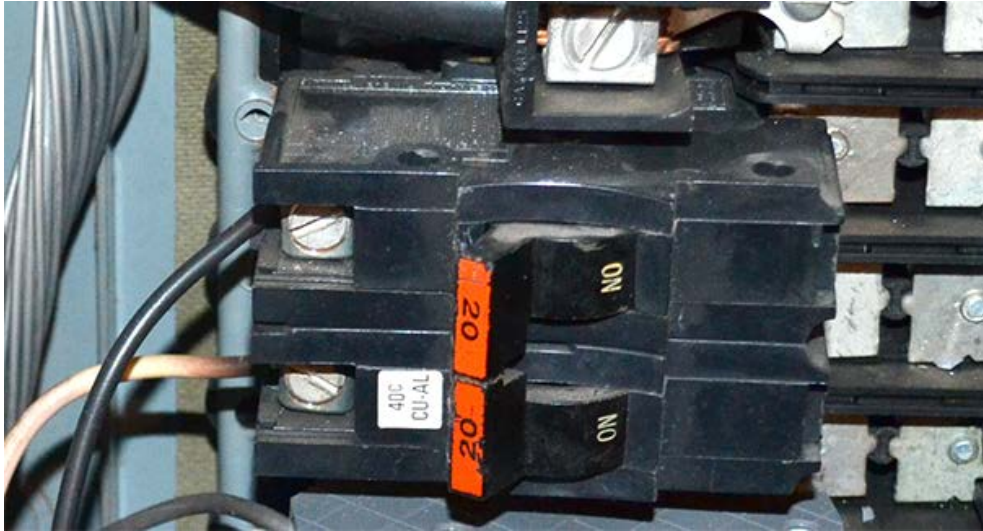
This is a close up view of a 20 ampere double-pole Stab-Lok breaker showing the handle shape and color.

Tests performed by the Consumer Product Safety Commission, and independent consulting engineers, concluded that certain *Stab-Lok* breakers do not trip according to requirements and in some cases can jam in the “on” position. This condition was most pronounced in the *Stab-Lok* two-pole version of the breakers.

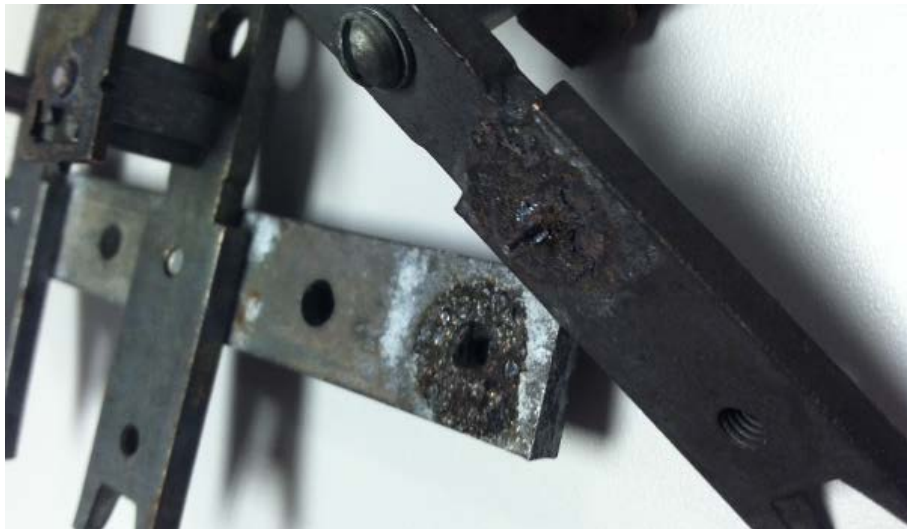
This is a failed, high-resistance, busbar connection inside a 200 ampere Stab-Lok panel. The arced-away steel screw holds the copper bar in the forefront to the aluminum bar in the background.

Based on these issues, when a Federal Pacific Electric *Stab-Lok* installation is discovered, the safest course of action is to replace it with a completely new panelboard and breaker installation.
