Electrical: Air Conditioning Safety Disconnect

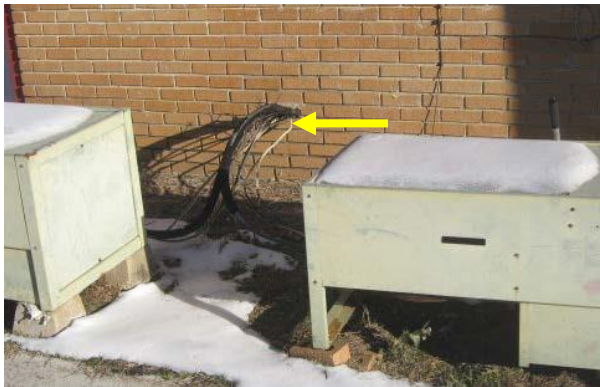
An electrical arc fault occurred within the control panel of an air conditioning unit. The arc fault continued down the line causing extreme overload to the remainder of the incoming electrical service and distribution panel. A fire ensued causing all electrical equipment in the switch room to be destroyed and heavy smoke damage to the church building resulting in a \$350,000 loss. Fire investigator found that the A/C unit was wired directly to the electrical service without the proper safety disconnect installed.

Image above shows an inadequate wiring set up for the central air conditioning units. Electrical is wired directly to the A/C condensing units, without a safety disconnect.

If your church does not have a safety disconnect installed for each air conditioning unit, a qualified electrician or licensed electrical contractor should be hired to complete this. This will ensure that the electrical work completed will meet current national and local electrical codes.

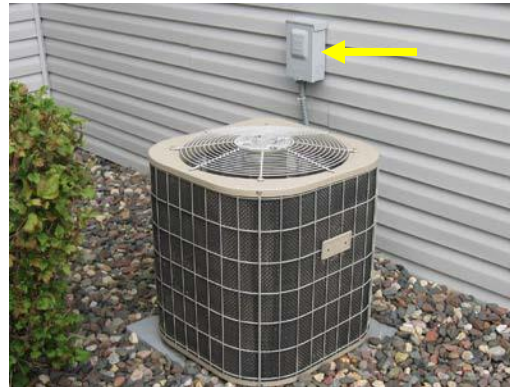
Image above shows the correct installation of an electrical safety disconnect switch.

This safety disconnect will have over current protection in the form of a circuit breaker or fuse. In the loss described above, the installation of an electrical safety disconnect would not have prevented the arc fault within the A/C unit, but the over current device would have prevented the down line damage to the main electrical distribution panel and subsequent fire and smoke damage.

Over current protection—circuit breaker or fuse.
