A Quick Check of Your Circuit Breaker Panel Can Shed New Light on Your Electrical Hazard Exposure

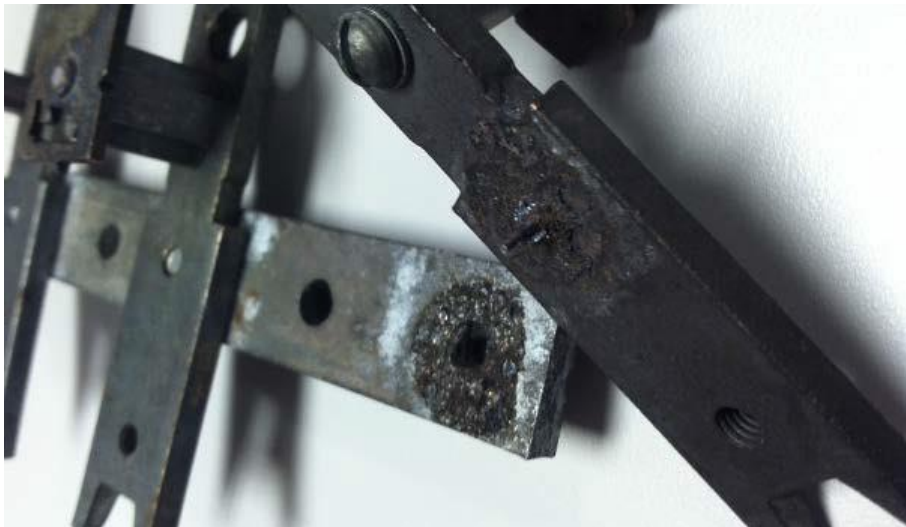
This is a failed, high-resistance, busbar connection inside a 200 ampere Stab-Lok panel. The arced-away steel screw holds the copper bar in the forefront to the aluminum bar in the background.

Based on these issues, when a Federal Pacific Electric *Stab-Lok* installation is discovered, the safest course of action is to replace it with a completely new panelboard and breaker installation.
