Copper Thefts in General

Preventing Copper Theft

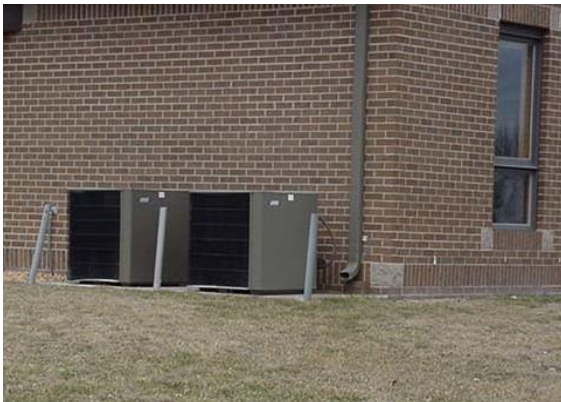
Example: This photograph illustrates AC units located at the back of the building creating an easy target for theft.

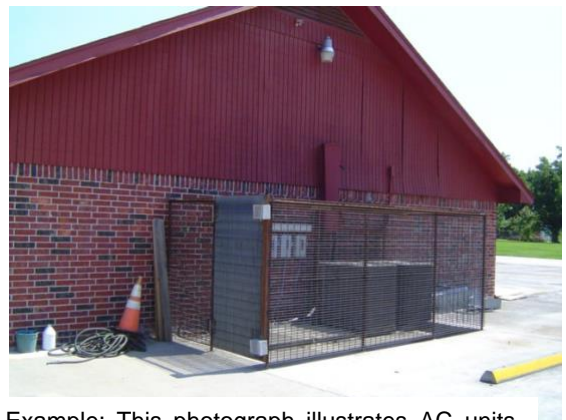
Example: This photograph illustrates AC units protected by a steel cage and security lighting.

- Consider the use of steel cages to enclose your AC units. The heavier the gauge of steel the longer it will take to cut. For example, 10-12 gauge steel can take one to two hours to cut. Do not use standard chain link fencing as it can be cut quickly.
